**Industry Reference Document (11) of (32)  
An Inside Look at Ft. Calhoun's Big Outage  
5 pages**

# Fort Calhoun's "Big Outage"

# An inside look at Fort Calhoun's “Big Outage”

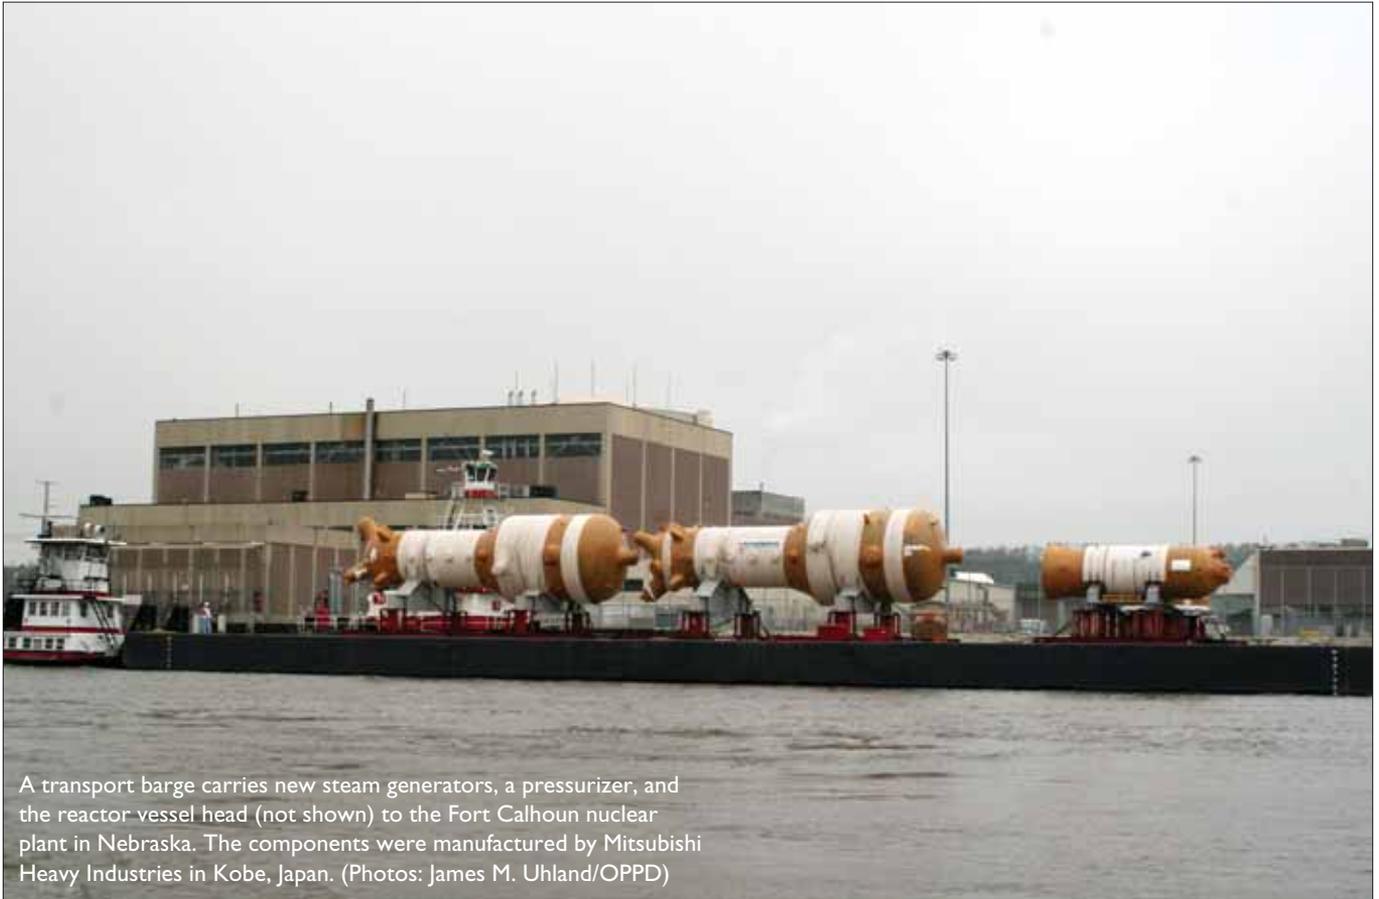
A transport barge carries new steam generators, a pressurizer, and the reactor vessel head (not shown) to the Fort Calhoun nuclear plant in Nebraska. The components were manufactured by Mitsubishi Heavy Industries in Kobe, Japan. (Photos: James M. Uhland/OPPD)

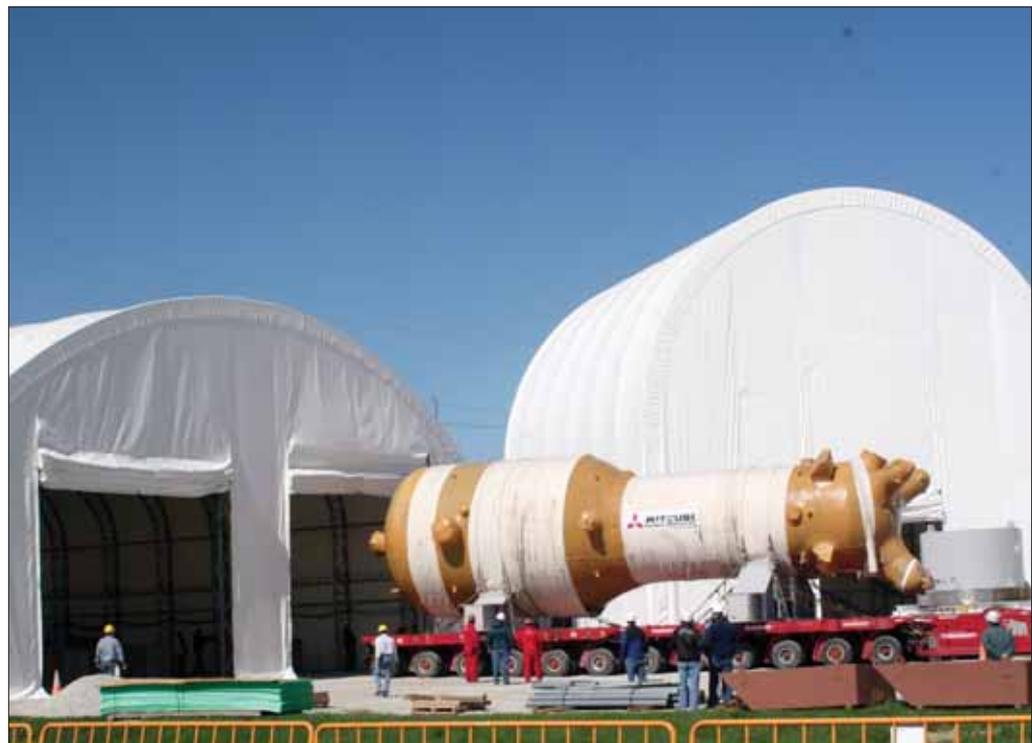
**Right:** The new steam generators are taken directly from the transport barge to a temporary storage tent on site.

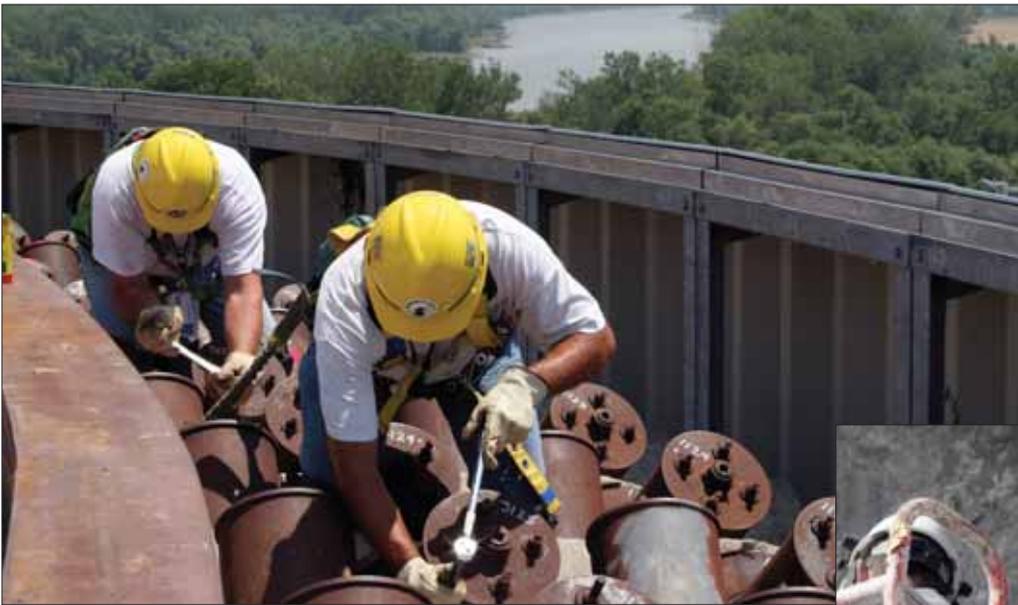
**Left:** Workers loosen tendons on the top of Fort Calhoun's containment building before their removal so that an opening can be created in the side of the containment building. The tendons are used as just one measure to keep the containment building tight and secure, similar to twine tied around a package.

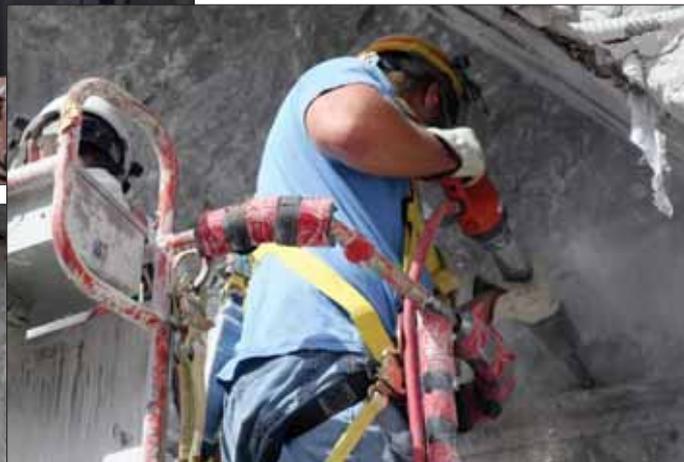
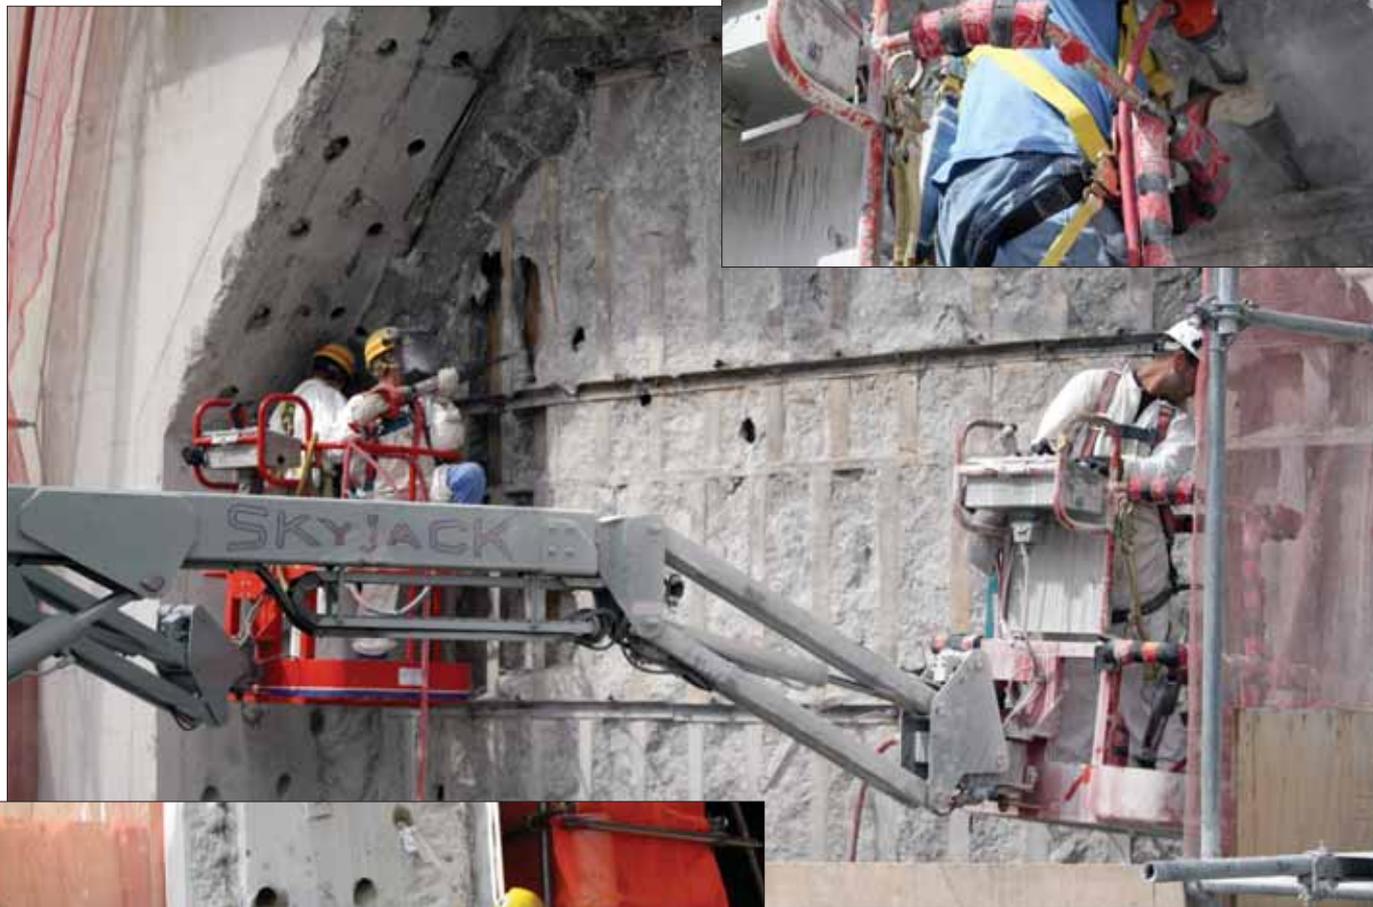
**Above & Inset:** In order to cut the opening in the containment building, workers use jackhammers to remove the final few inches of concrete surrounding the rebar that is part of the containment's liner.

One major step in replacing the main components was creating an opening in the containment building large enough to accommodate the massive equipment that would be moved in and out of the building. Because the walls of the containment building consist of four-foot-thick reinforced concrete, this was no small task. The process of cutting through the containment wall took about a week. Workers accomplished the task using industrial-sized jackhammers, cutting torches, and smaller jackhammers.

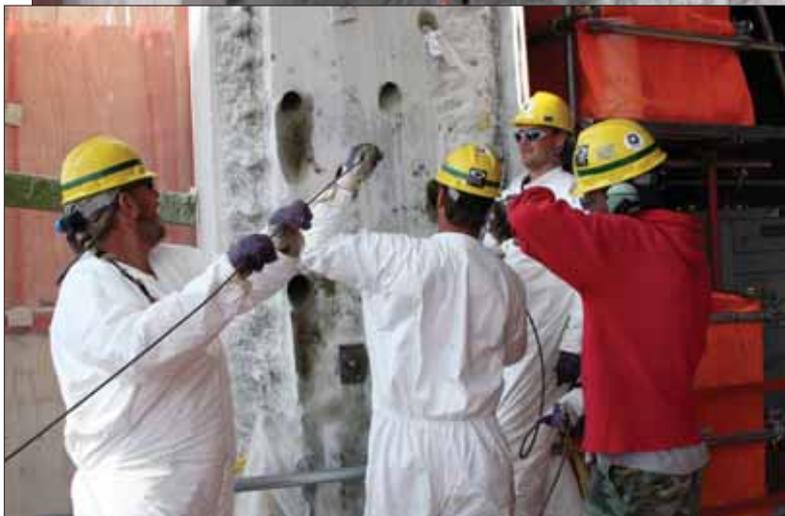
**Left:** With the containment opening created, workers clean out a channel that once contained a tendon.

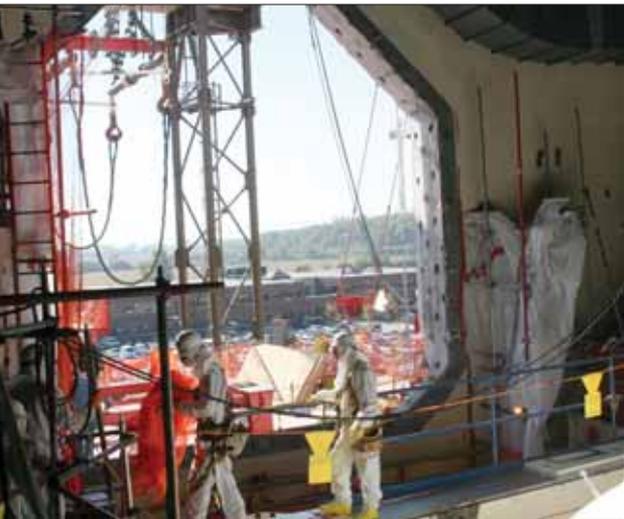
**Above:** This view is from inside the containment building looking out. Workers prepare for the moving of large components through the opening.

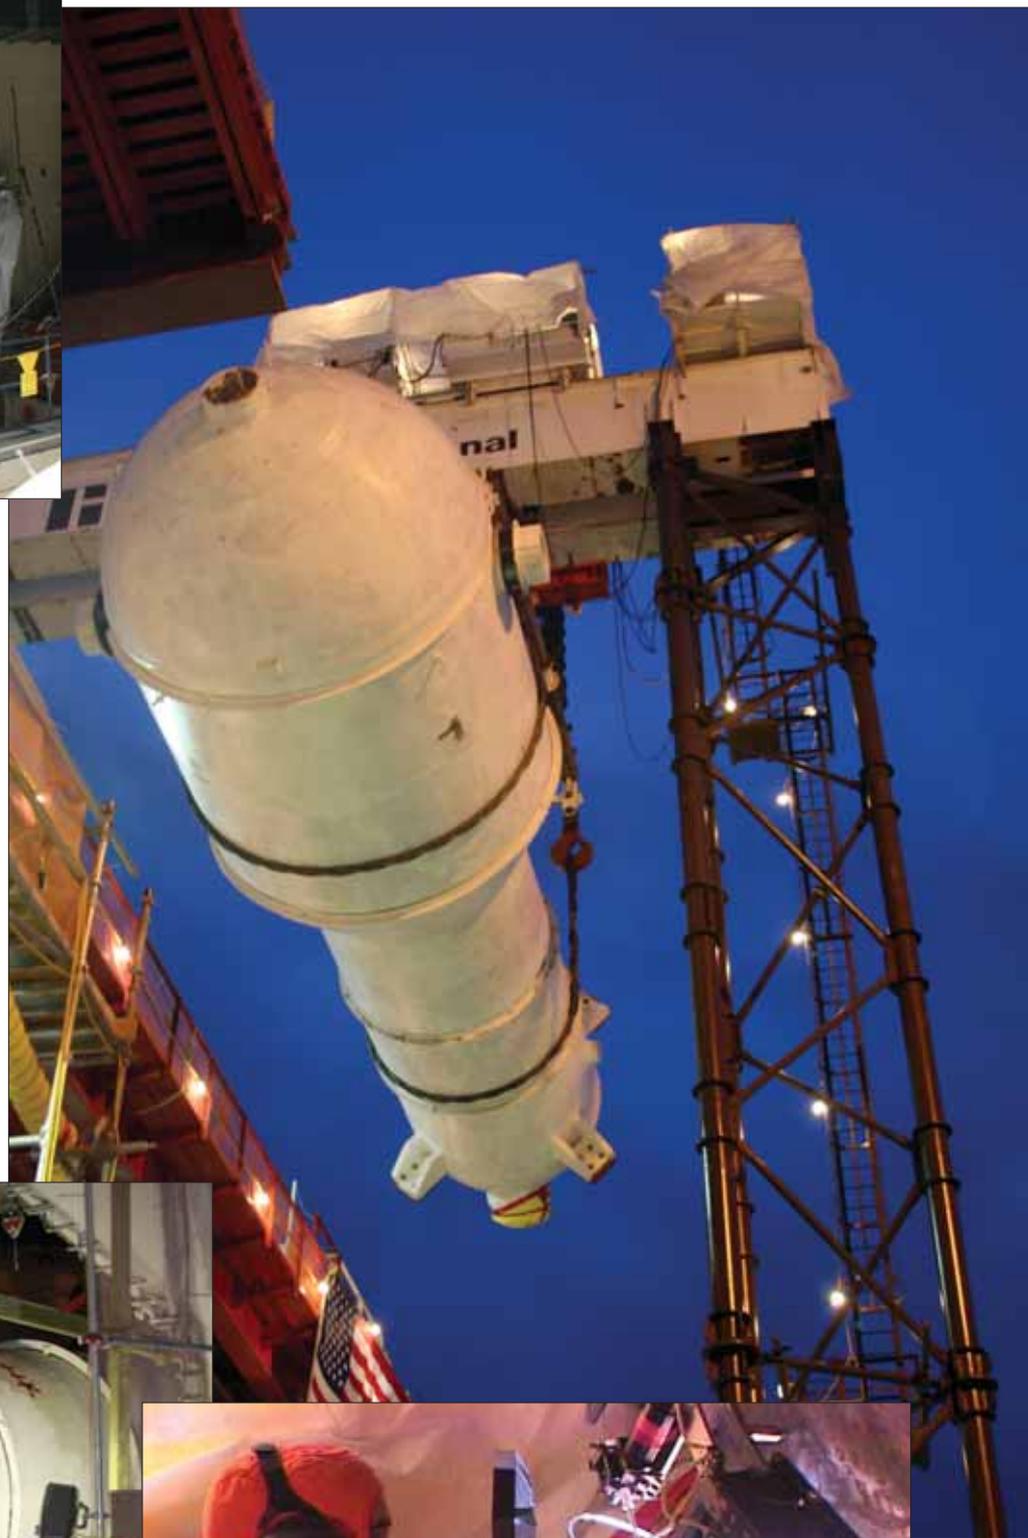
**Right:** One of the two old steam generators is removed from containment to make way for the new components. The old steam generators were moved to the ground from the holding platform, about 80 feet in the air, at a rate of 1 inch per minute.

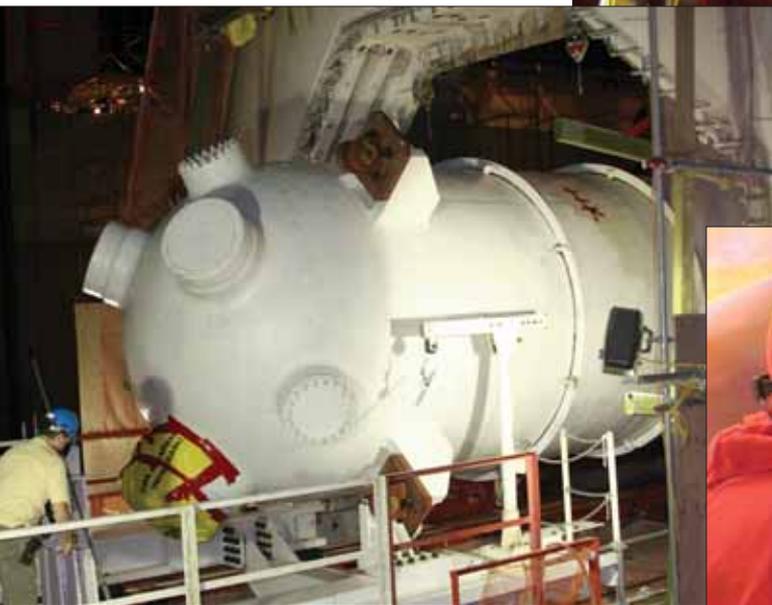
**Below:** As it makes its way out of the containment opening, an old steam generator is surveyed by the plant's Radiation Protection group.

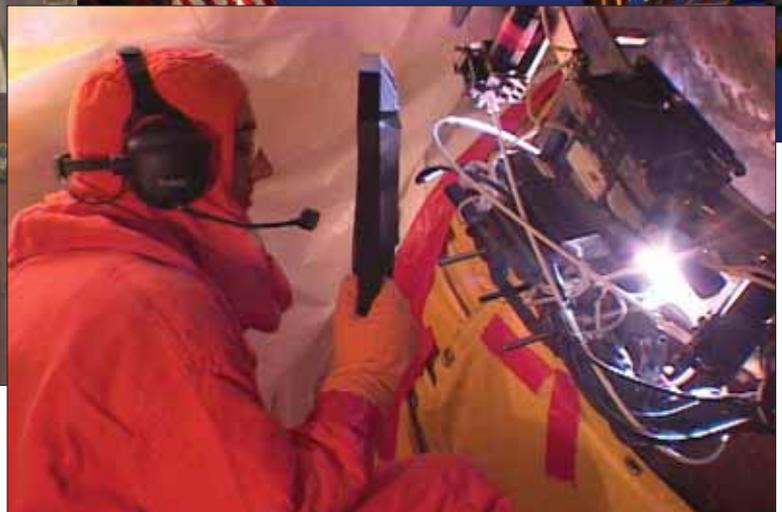
**Below right:** A worker welds one of the new steam generators into place.
